Sinclair Spectrum

SERVICING MANUAL

ZX SPECTRUM®

Prepared by THORN (EMI) DATATECH LTD
for SINCLAIR RESEARCH LTD

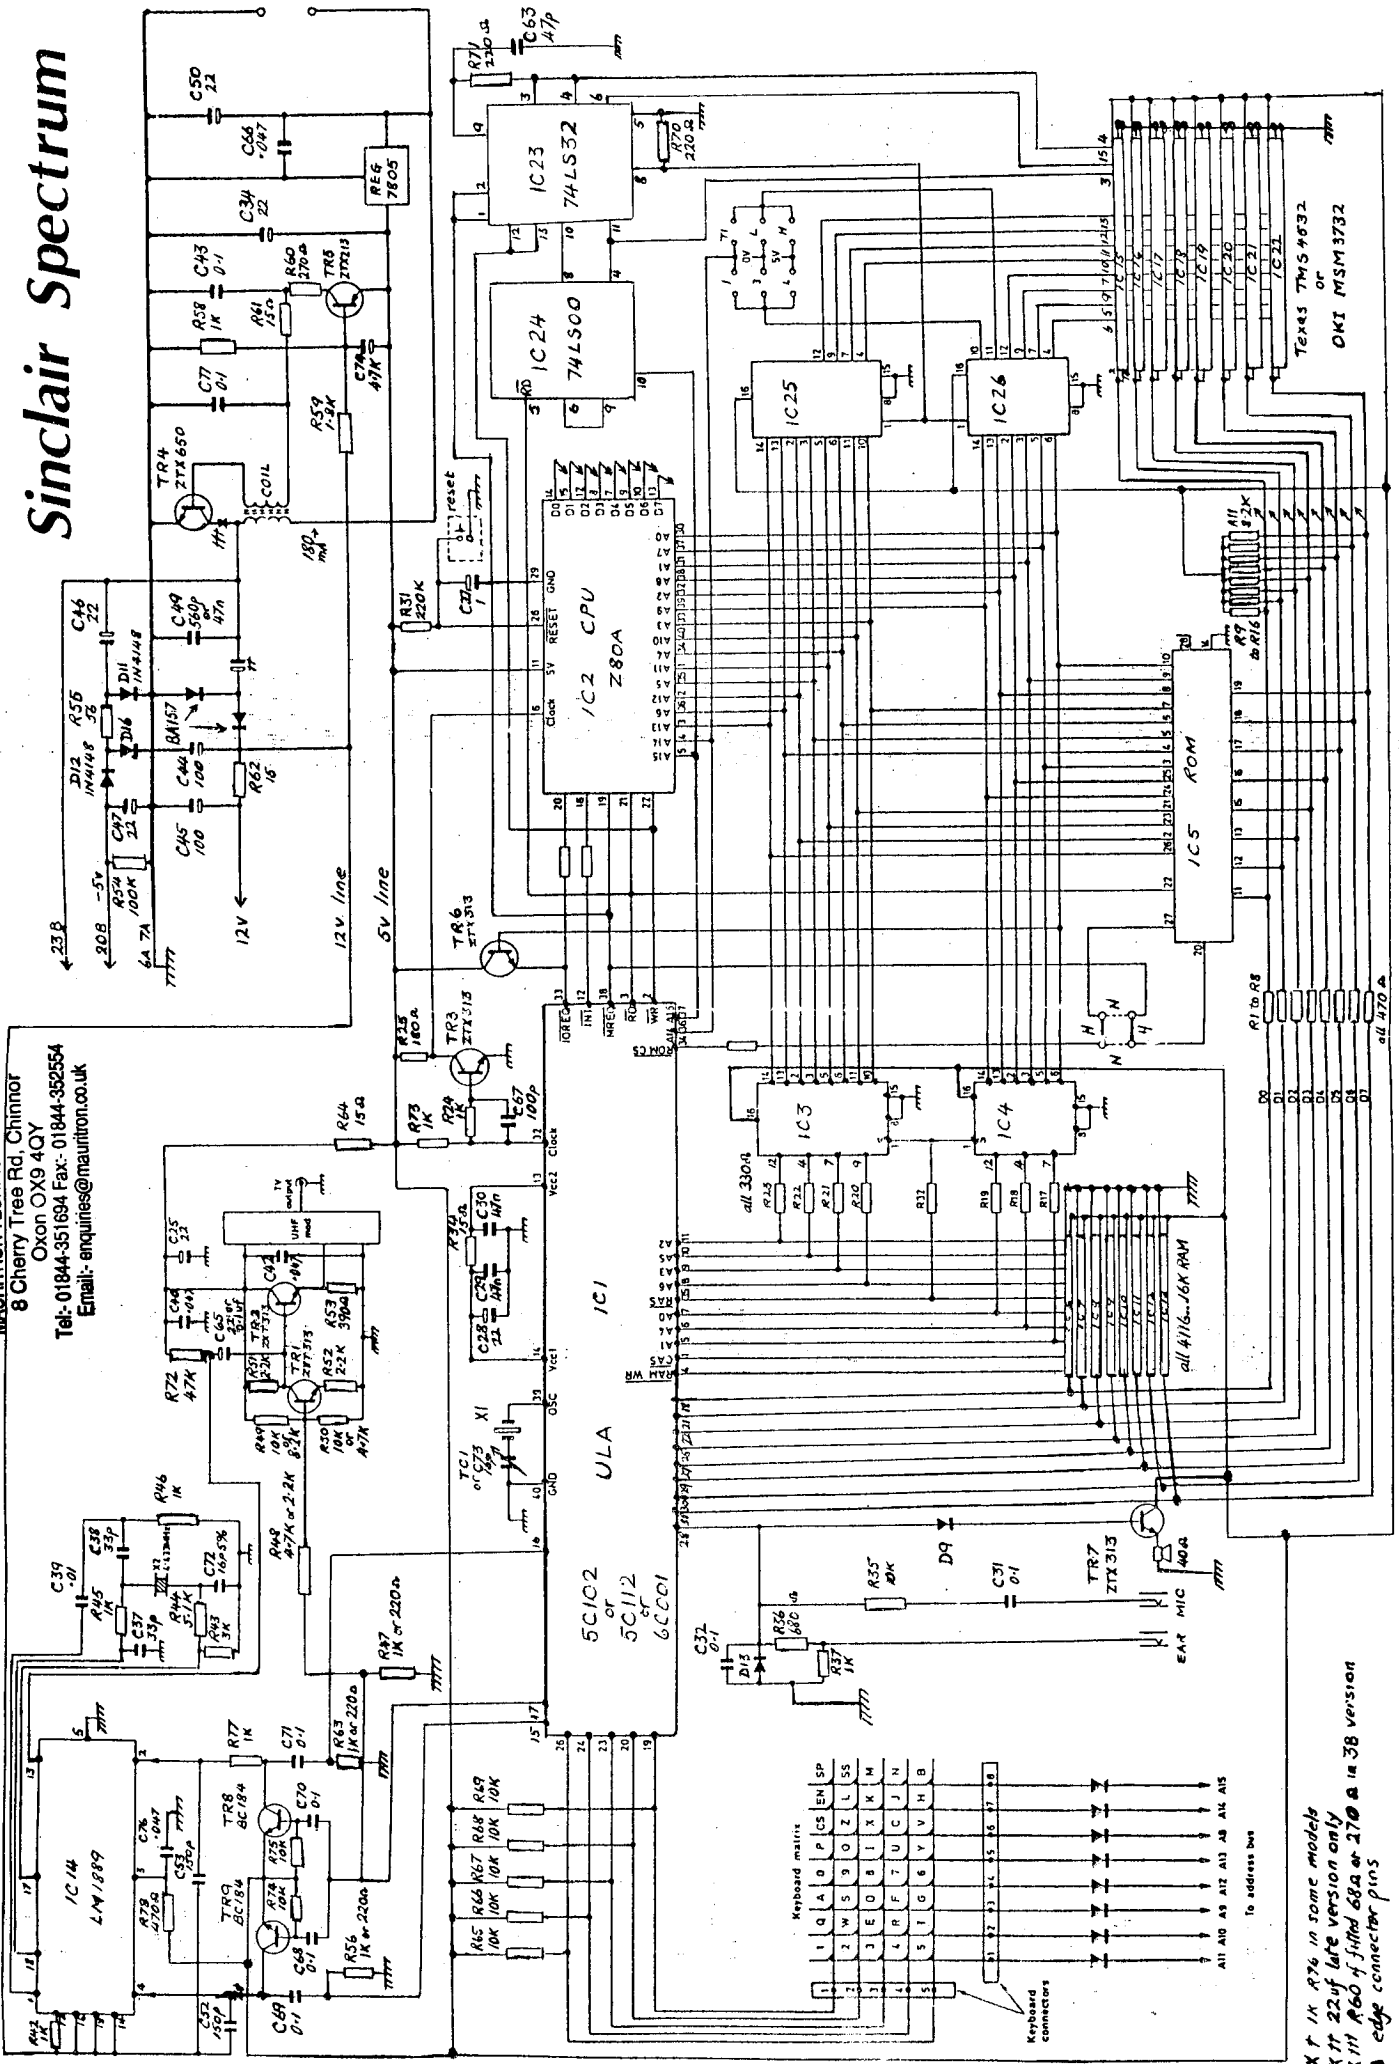
X T 1K R76 in some models
 X T1 R22uf late version only
 X T11 R60 of fitted 68A or 270 A in 38 version
 A edge connector pins

Modification to voltage generator circuit: Where not fitted already, insert a 22uf capacitor between the TR4 and D15 as shown in the circuit diagram, this will ensure the correct 12v supply. On early models replace R60 by a 270 ohm resistor and fit C74 if missing. Ensure that the 12v supply is 12v.

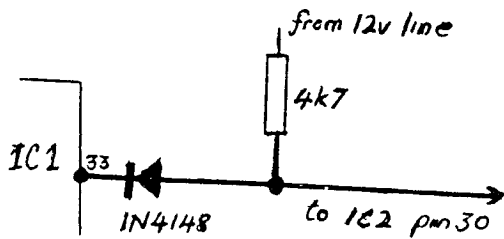
In very versions, instead of TR6 a somewhat unreliable, resistor/diode was used which should be modified as shown in the centre pages.

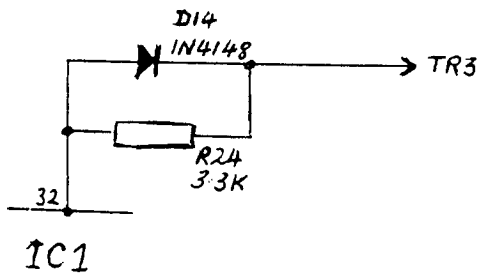
Modifications associated with IC1

This very unreliable circuit was used in very early versions from pin 32 to base of IC1. This circuit should be modified to that shown in the centre pages if not already done.
