Sinclair Spectrum

SERVICING MANUAL

ZX SPECTRUM®

Prepared by THORN (EMI) DATATECH LTD
for SINCLAIR RESEARCH LTD

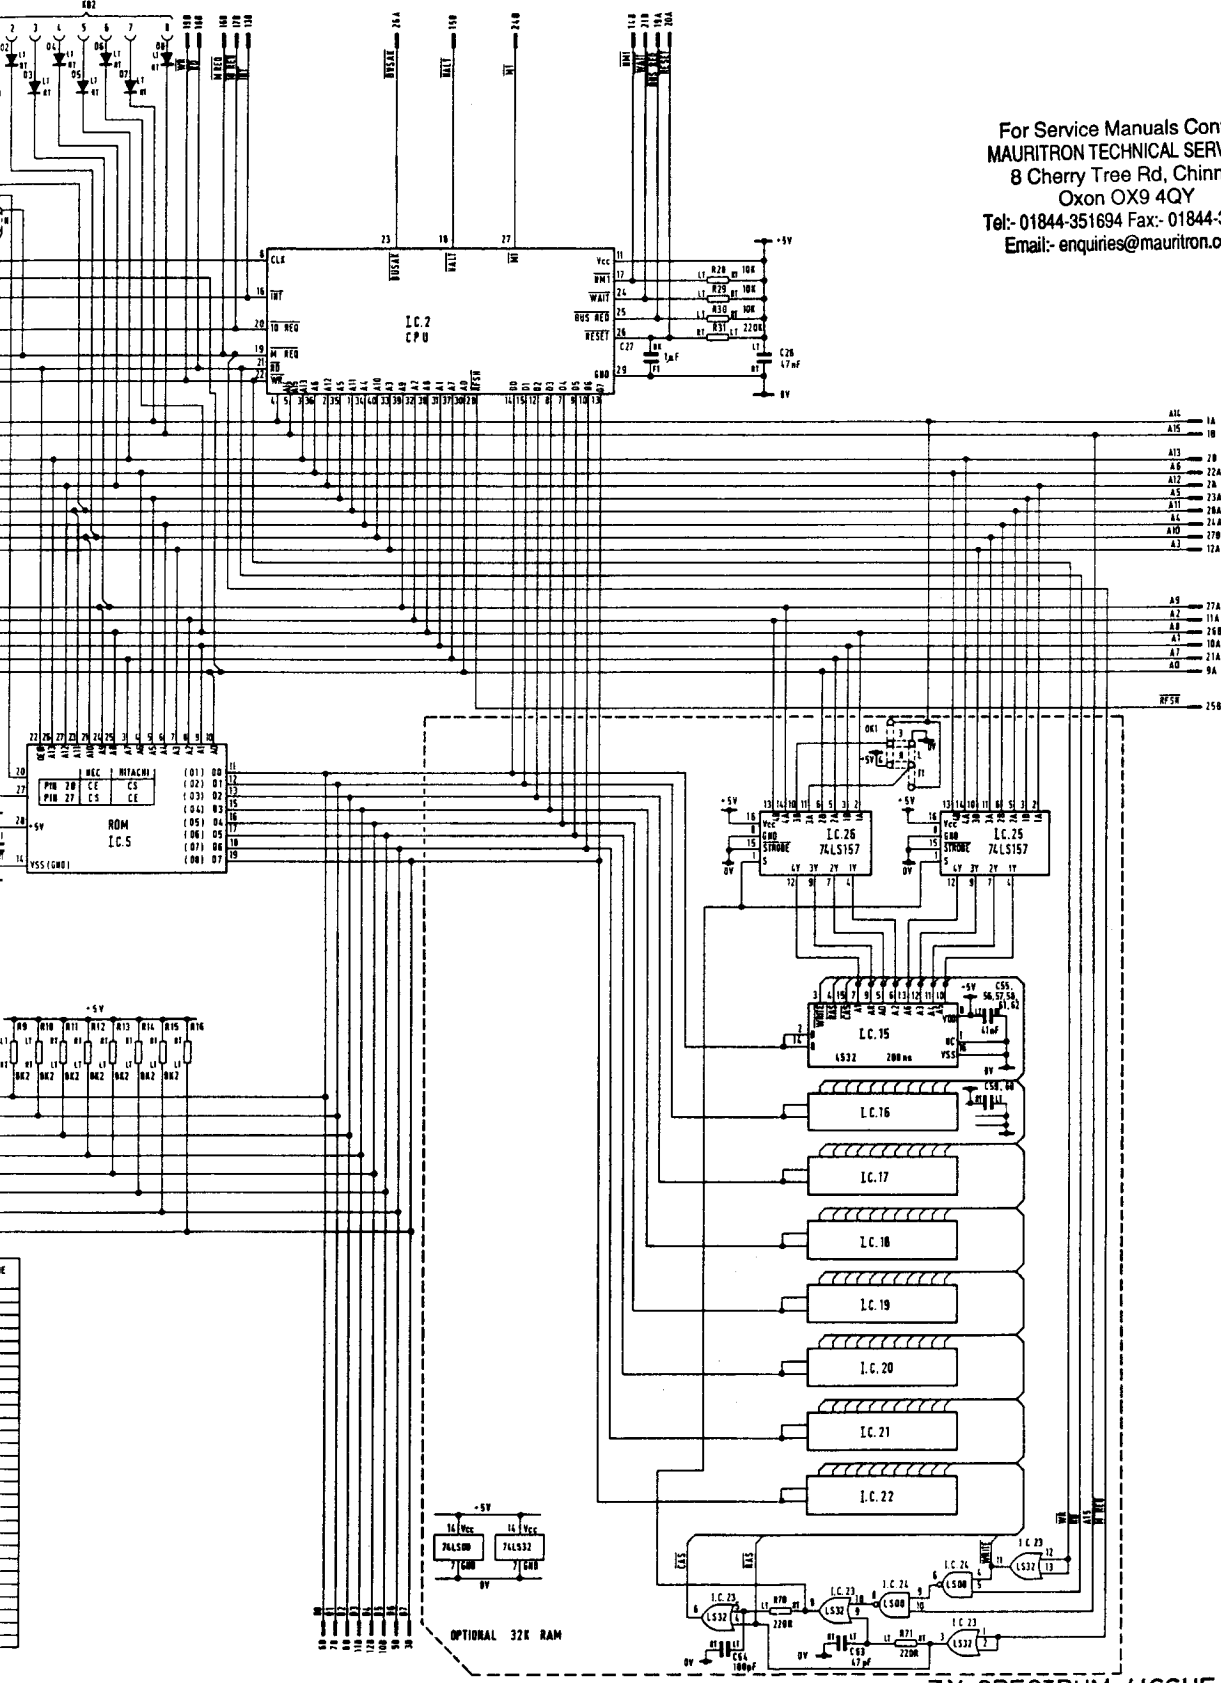
ZX SPECTRUM (ISSUE 3) FIG. 1.5
 CIRCUIT DIAGRAM ESK12750
 ISSUE A

Although functionally similar to the Issue 3 board, the layout differs. The DC converter design has been improved, providing greater power supply reliability. Component changes are as follows (see Fig 1.5 for details):

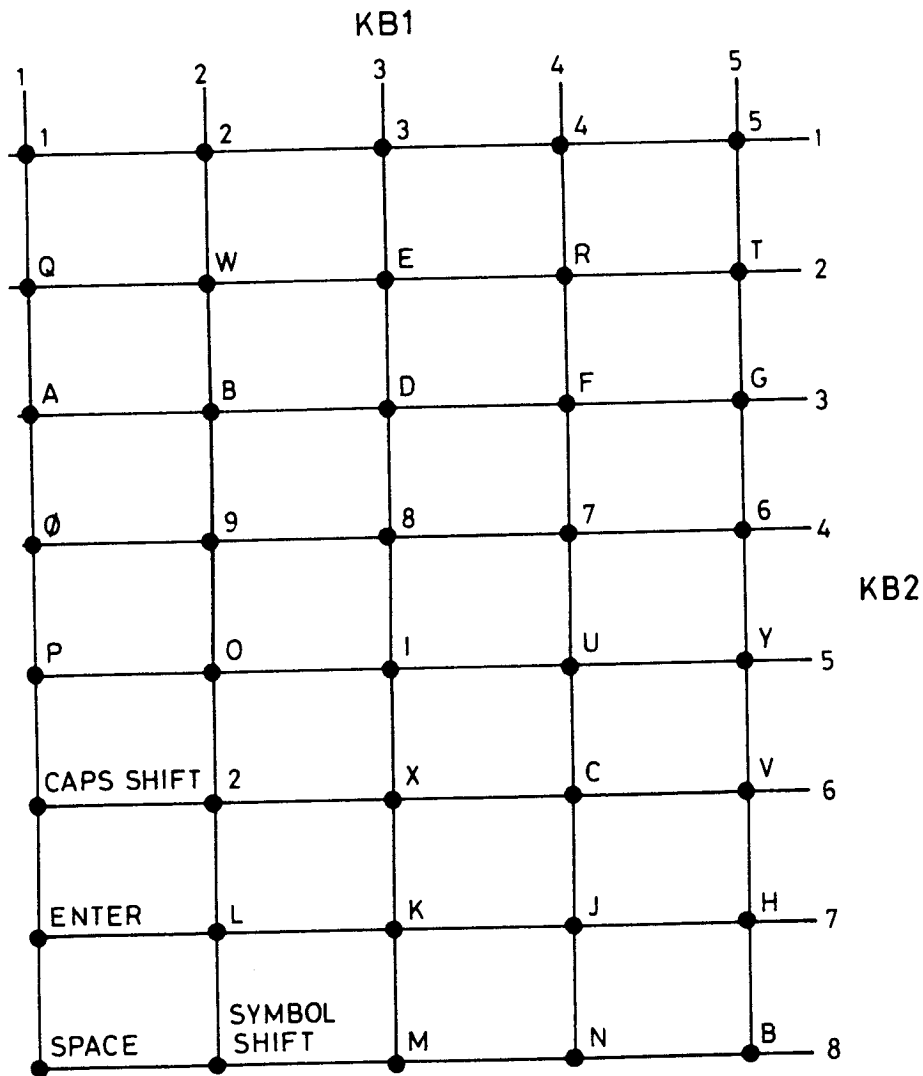
FIGURE 4.1 KEYBOARD FORMAT

The keyboard is connected horizontally in eight blocks of five keys and vertically in five blocks of eight keys. Figure 4.1 shows the configuration. It follows that if any block of five keys fail the fault is with KB2 circuitry or the 8-way membrane, and that if any block of eight keys fail the fault is with KB1 circuitry or the 5-way membrane. Possible keyboard faults are listed in paragraph 2.6.

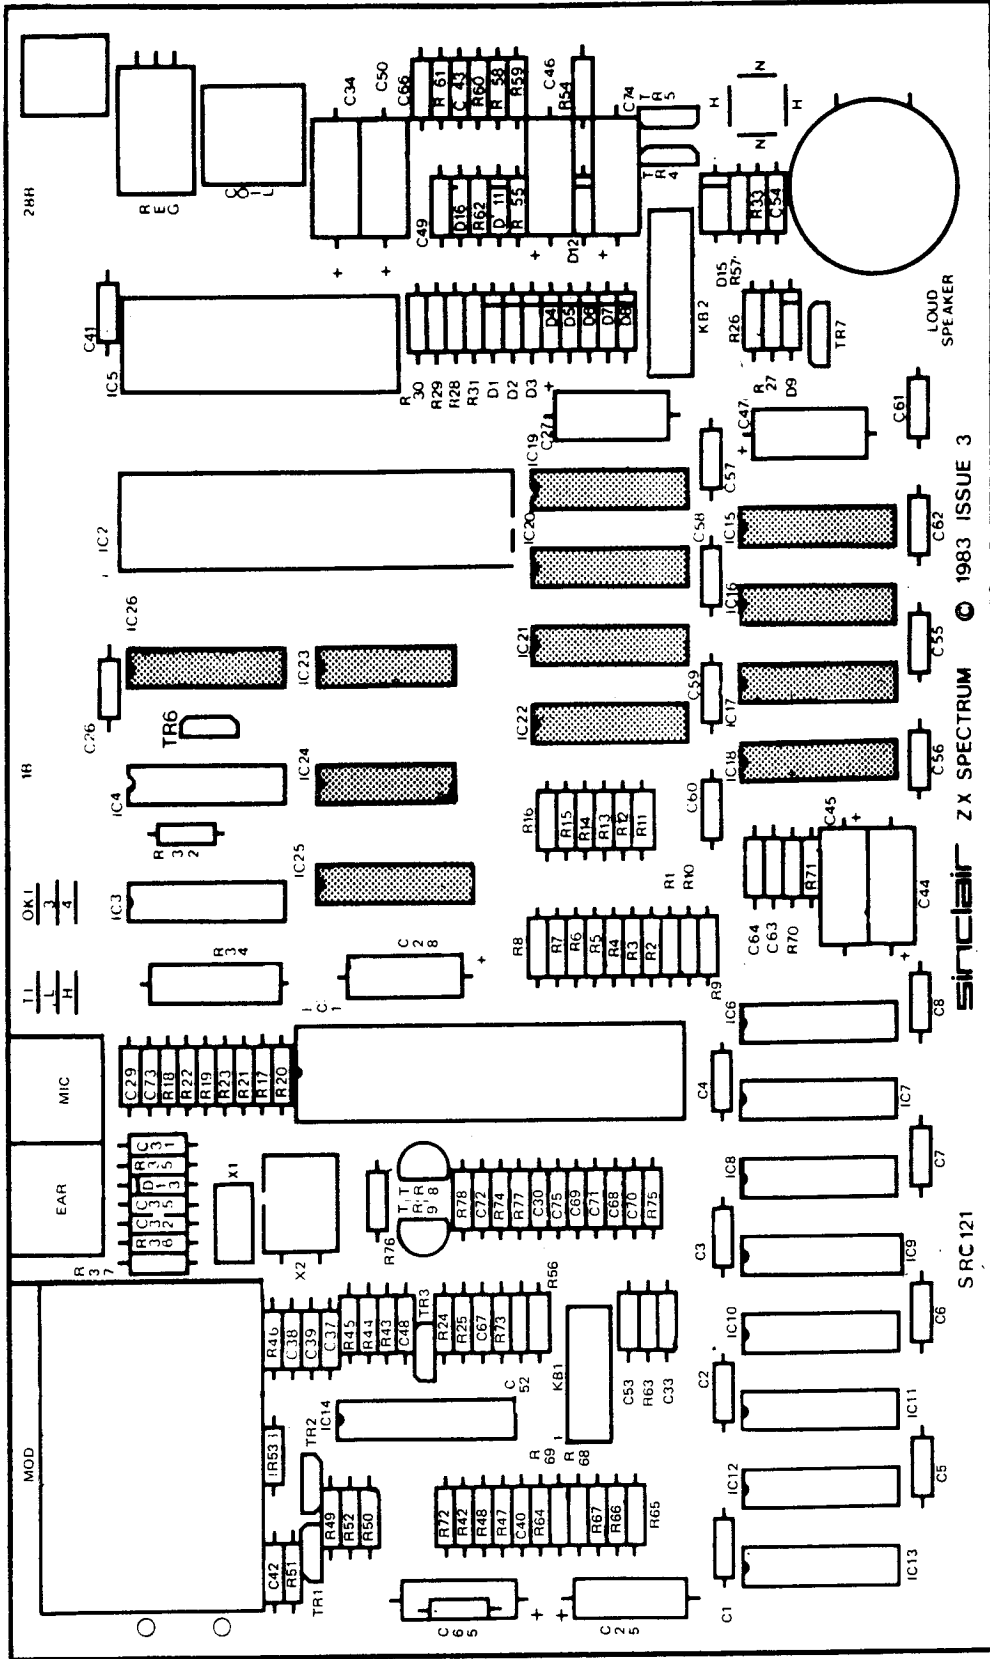
FIGURE 4.3 EXPANSION MEMORY IC LOCATIONS

For both the Issue 2 and the Issue 3 boards the memory upgrade is accomplished by plugging four logic ICs and eight memory ICs into existing board sockets. Depending on the types of memory IC used, appropriate circuit links must be fitted on the board. Figure 4.3 shows the layout of the area of the board containing the empty sockets. The Issue 3 board is shown which also gives positions (top left of diagram) of the links.

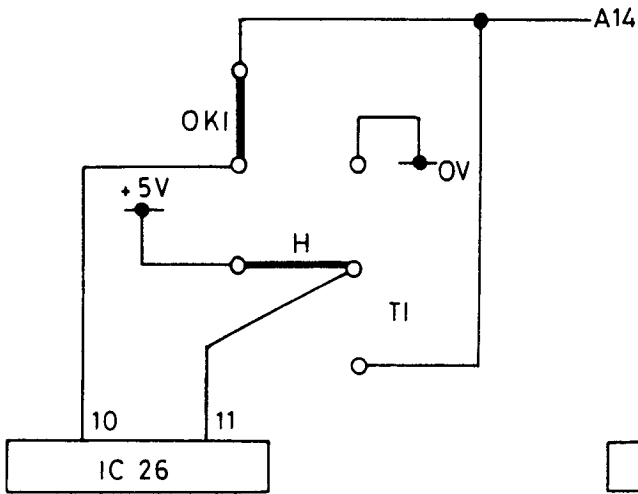
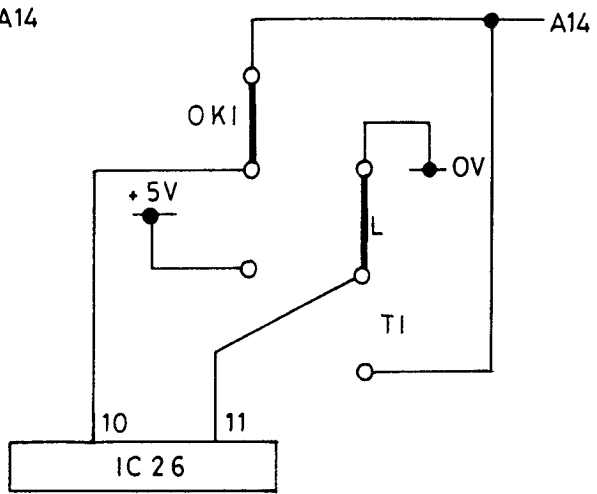
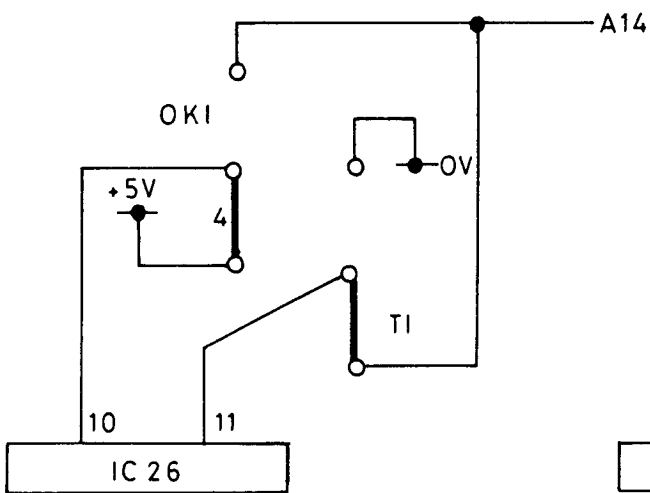
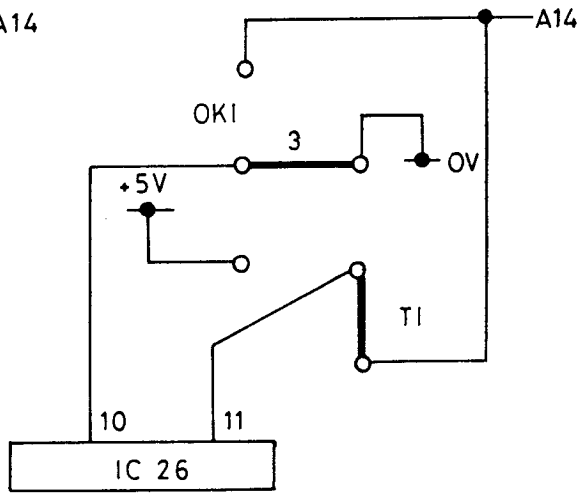
FIGURE 4.4 ISSUE 3 LINKS vs IC MANUFACTURER AND TYPE

- NOTES:
- (1) All extension RAM ICs must be of the same type.
 - (2) Two links must be fitted on the board (grid located between edge connector and m/c jack socket) depending on memory manufacturer and type (high or low enable). See Figure 4.4 for link positions vs manufacturer and IC type.
